DH82A TIGER MOTH REBORN

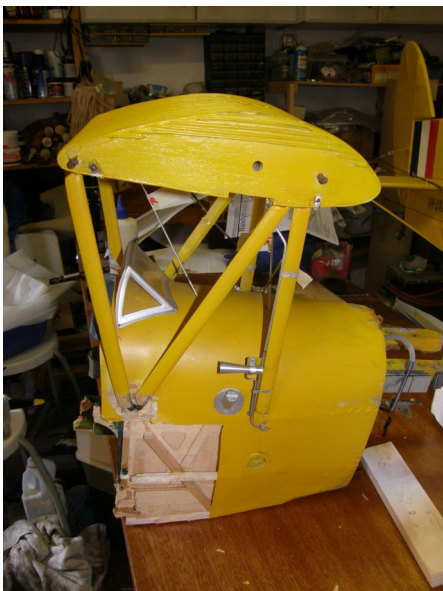
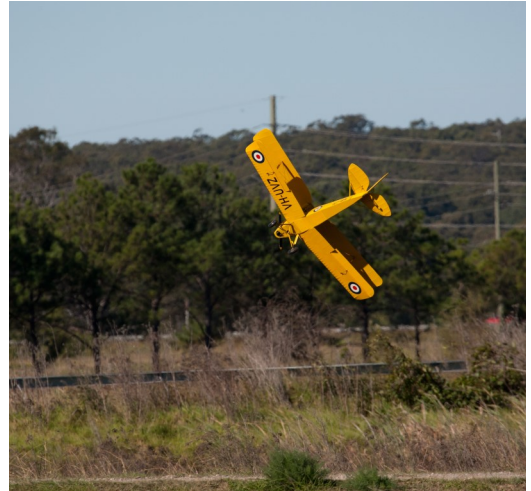
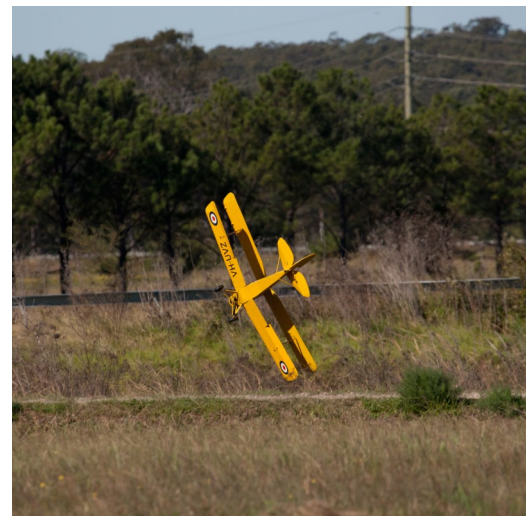
My first thought were to try to nurse it back to the field but the strong tailwind had me turning away for a landing in a clear area across the access road. We got too slow, tipped stalled and you can see from the photos that the result wasn't going to be pretty.

The Tiger cartwheeled on touching down and the wings because they are a braced unit came out of it fairly well. Upper left wing had damage to the root rib and some of the bracing wires and structure was damaged. Quite minor really. The fuse was another matter, broken in half at the front cockpit, this was going to take some serious work.

Incidentally, the fuse is the weakest part of the build with the front and rear sections being built in two pieces and grafted together. It had broken here previously after not much more than a hard landing. This was the time to do a proper repair.
