DH82A TIGER MOTH REBORN

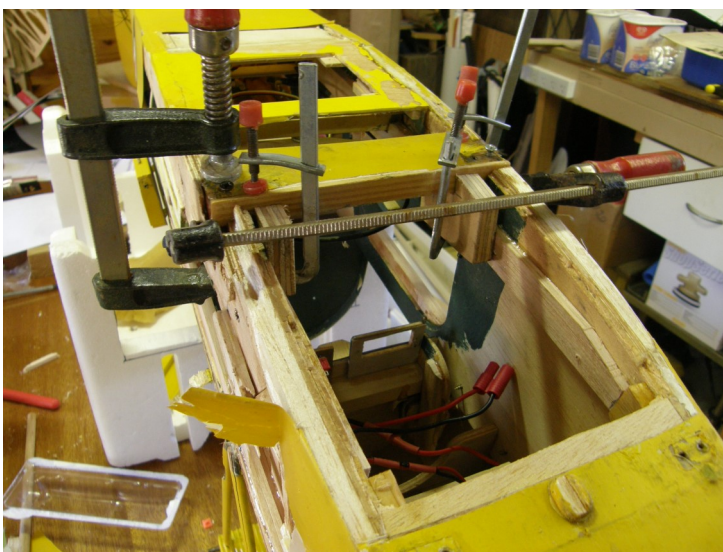
Clamps everywhere, fore and aft holding the front and rear together and clamps on both sides holding the original frame to the new longeron sections, When the two halves were brought together and alignment was established, screws were inserted through the existing frame and into the 4 longerons. This allowed me to check everything before the glue was applied. Liberal amounts of 24hr Epoxy was then applied to the frame and longerons and with clamps and screws it was held together to allow the glue to dry for a minimum of 48hrs. Now the fun started, adding in the gear mounting blocks and re-building the undercarriage, changing the engine mounts to accept a new OS200 four stroke, re-plumbing the fuel system, repairing the fibreglass cowl, sorting the throttle linkage and on-board glow system. And to finish off, ordering some moulded parts from Flair UK.
