DH82A TIGER MOTH REBORN

DH82A Tiger Moth Re-birth continues.

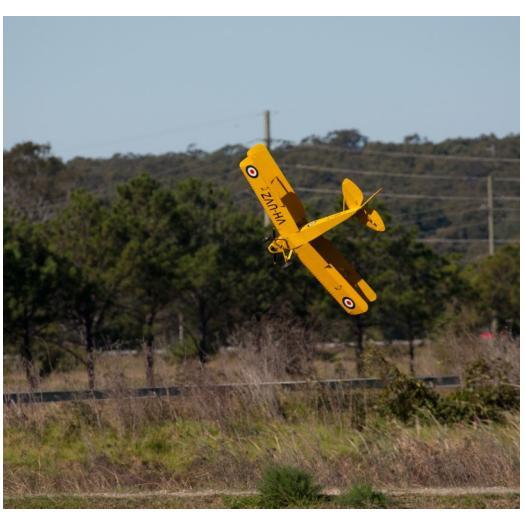
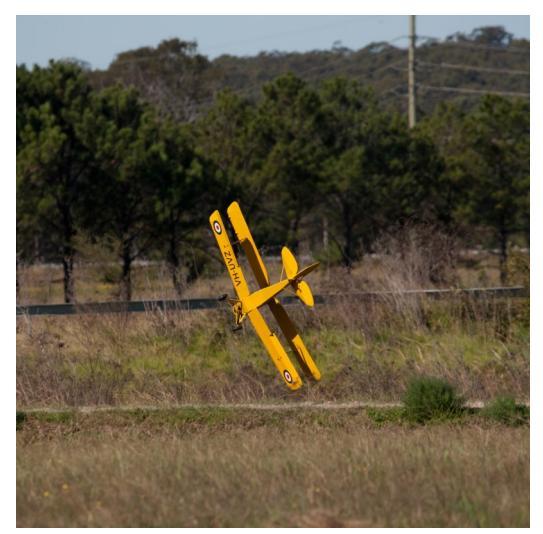
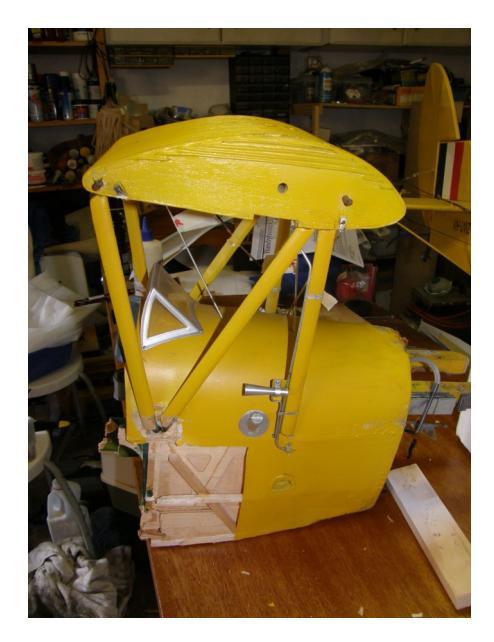
My first thought were to try to nurse it back to the field but the strong tailwind had me turning away for a landing in a clear area across the access road. We got too slow, tipped stalled and you can see from the photos that the result wasn't going to be pretty.

The Tiger cartwheeled on touching down and the wings because they are a braced unit came out of it fairly well. Upper left wing had damage to the root rib and some of the bracing wires and structure was damaged. Quite minor really. The fuse was another matter, broken in half at the front cockpit, this was going to take some serious work.

Incidentally, the fuse is the weakest part of the build with the front and rear sections being built in two pieces and grafted together It had broken here previously after not much more than a hard landing. This was the time to do a proper repair.

All the decorative bits were removed, along with covering, undercart, tank, rudder controls, batteries and motor. Do I stick with the motor? Or is it time for a change?

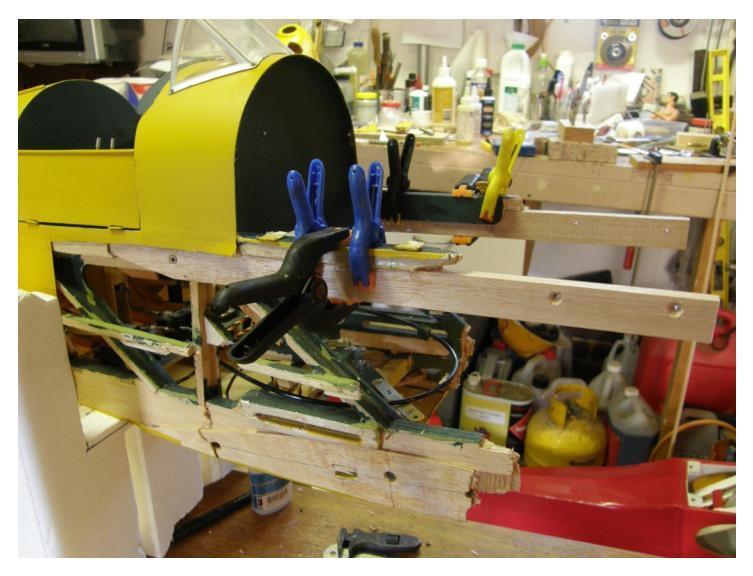
After a bit of trial fitting it became apparent that a bit of glue wouldn't do the job so of to the local Bunnings for some Tassie Oak hardwood for bracing. I chose 18 x 8mm and 4 pieces would be installed from forward of the front cockpit to aft of the rear. Each piece would be approximately 400mm long.

More clamps, just as well I am a frustrated cabinet maker! Once all 4 new longeron sections are in then the two halves will be brought together

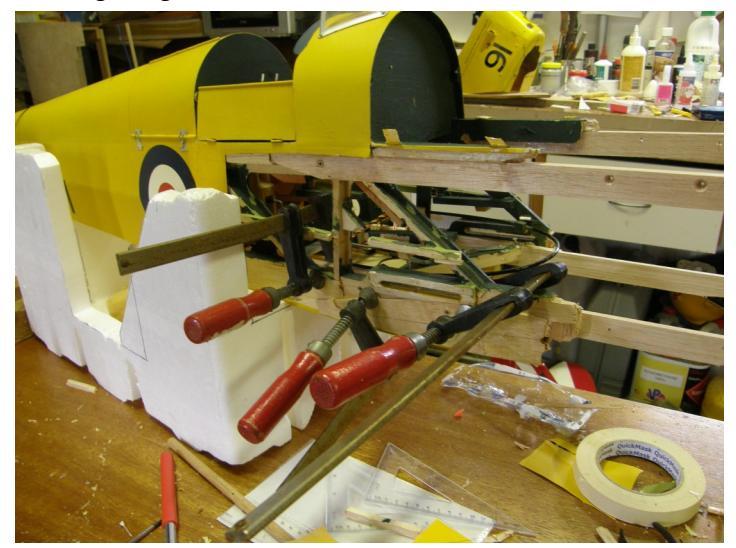
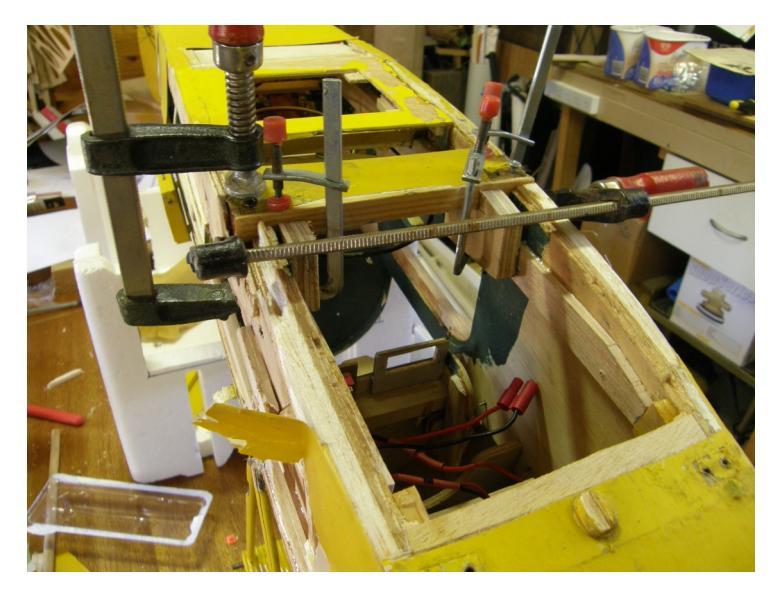
I started by grafting the new upper longerons into the rear portion of the fuse using epoxy, clamps and screws.

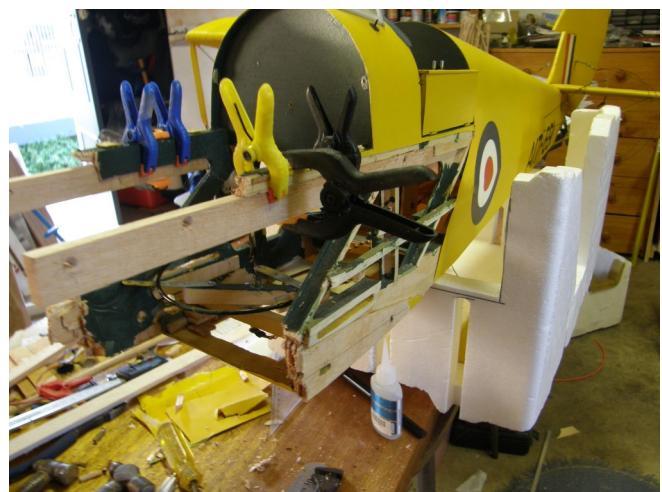
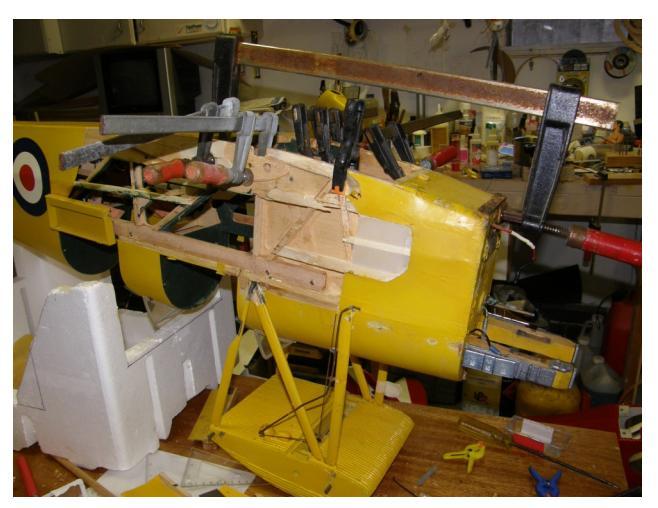
Clamps everywhere, fore and aft holding the front and rear together and clamps on both sides holding the original frame to the new longeron sections, When the two haves were brought together and alignment was established, screws were inserted through the existing frame and into the 4 longerons. This allowed me to check everything before the glue was applied. Liberal amounts of 24hr Epoxy was then applied to the frame and longerons and with clamps and screws it was held together to allow the glue to dry for a minimum of 48hrs. Now the fun started, adding in the gear mounting blocks and re-building the undercarriage, changing the engine mounts to accept a new OS200 four stroke, re-plumbing the fuel system, repairing the fibreglass cowl, sorting the throttle linkage and onboard glow system. And to finish off, ordering some moulded parts from Flair UK.

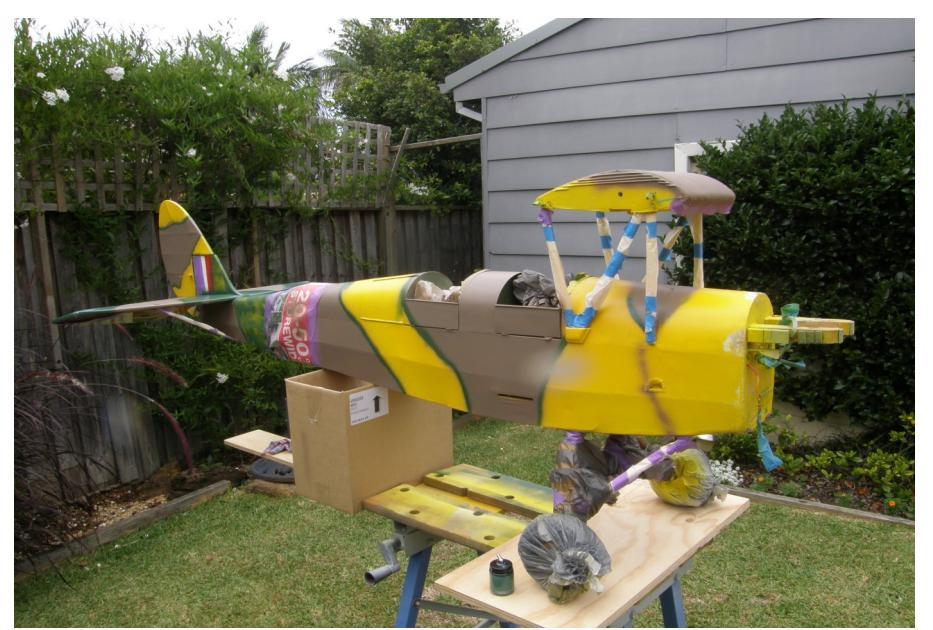
Now the masking commenced, we needed bands of the old yellow on the upper wings and the fuselage and to get a sharp edge I prefer to use 3M Fineline tape (or generic brand) that gives a very sharp edge and this is backed up with low tack masking tape and paper.

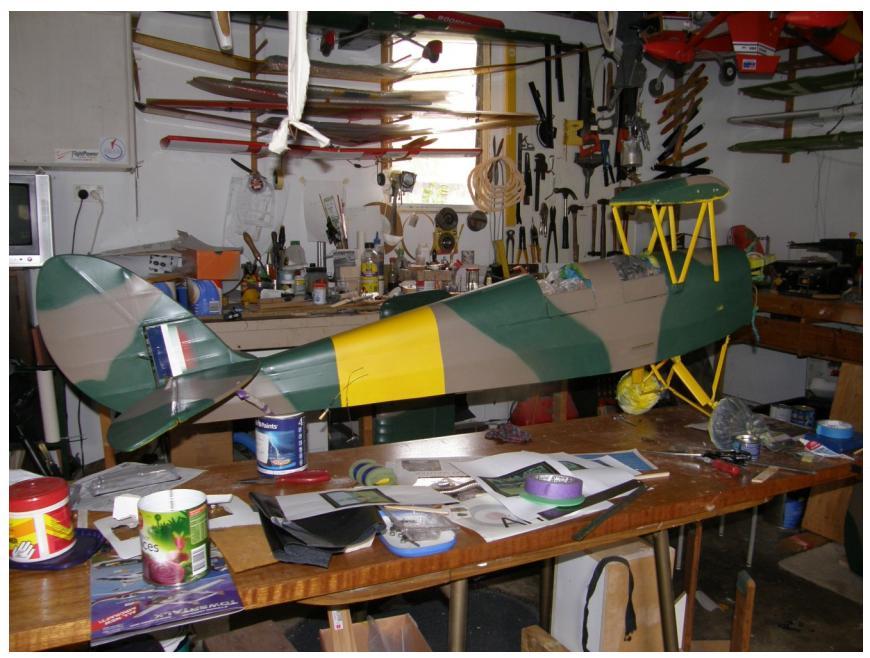
Now when all the masking has been completed it was time to mix the paint. The chosen paint was acrylic water based as it is east to use and washes up with water. I was using an airbrush for the camouflage colours and generally the edges are not sharp so masking wasn't required. Thinning is usually required with

low air pressure. I used a bit of cardboard to stop over spray. I also spray onto the area to be painted to help avoid the overspray.

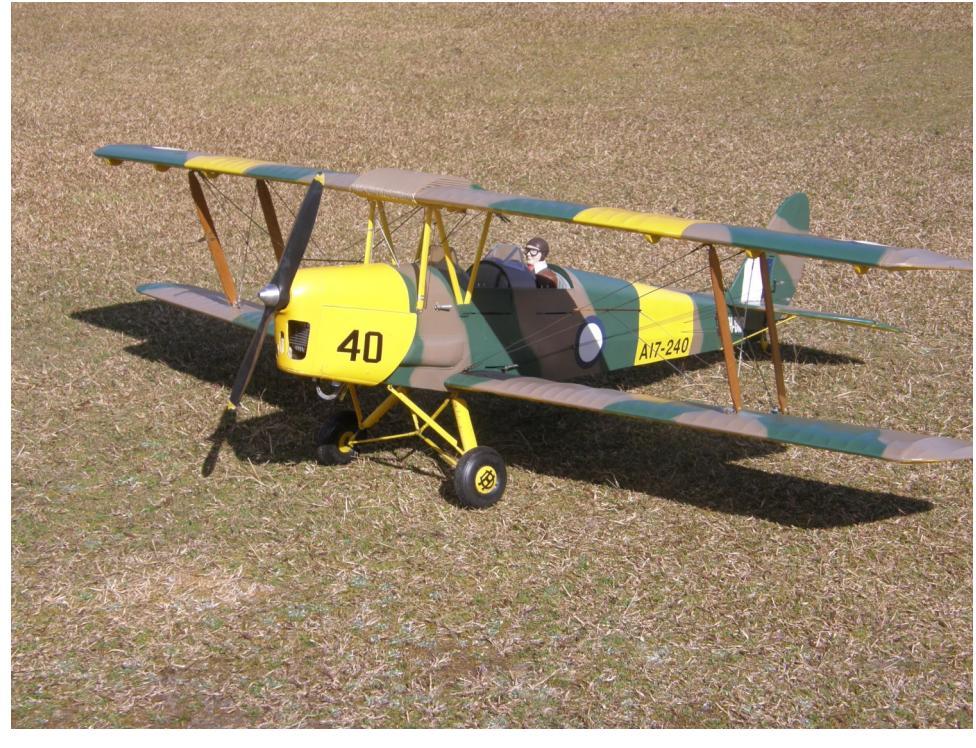
Next the decals were added before an Estapol satin clear coat was added to protect the acrylic and provide a better fuel proofing. This was applied with a normal spray gun with the paint thinned down so 2

thin coats were applied.

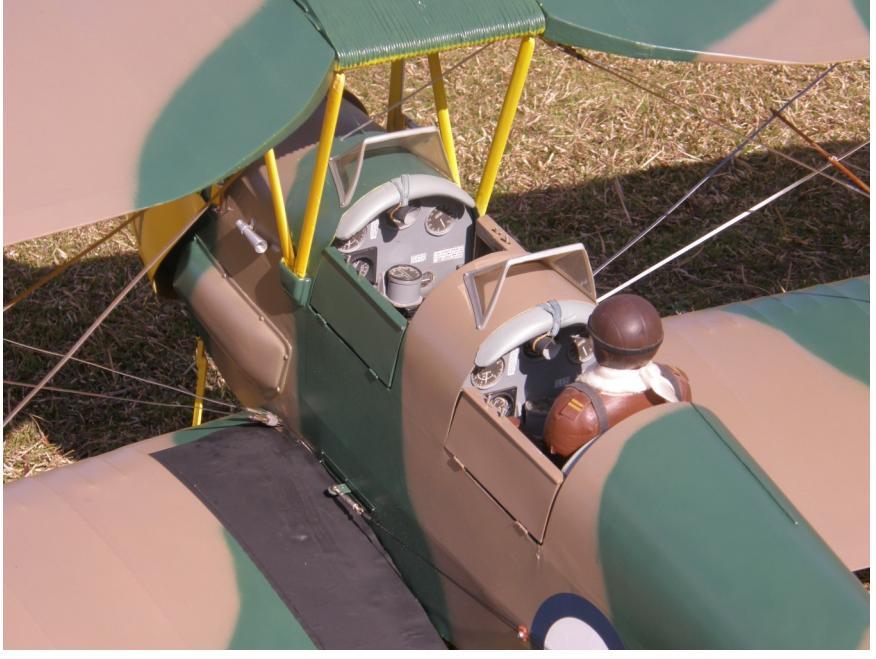
At the field the Heavy Model inspector was doing his thing as the model needed to be re-certified due to the major rebuild. Thankfully it passed inspection and the Tiger was assembled, rigging checked, Rx

battery voltage checked, range check completed, engine run and tuned so I had now run out of excuses.
