Chipmunk Follow Up.

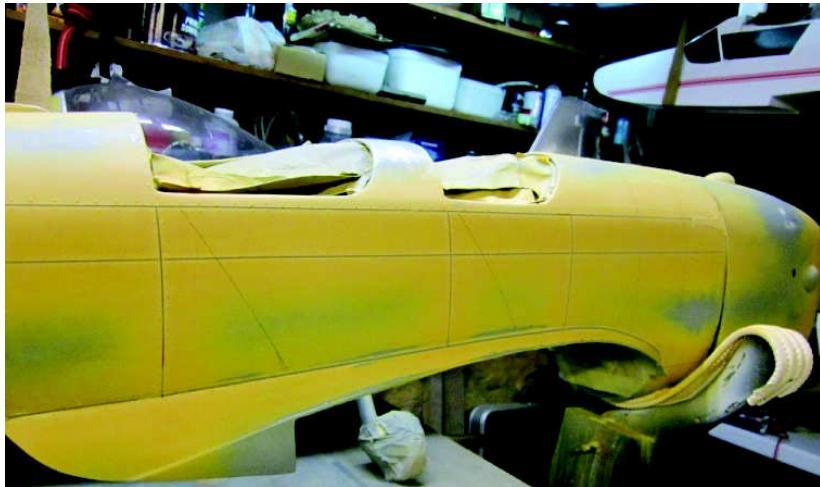
The down side of my rush of blood to fix the canopy is that I now have to re-do all the surface detail after sanding off all the old paint. These pictures are of the plane in primer after panel

lines and rivets have been added. The Chippie doesn't have that many panels but it does have a gazillion rivets. It took me about 5 days to do the detail and now she is ready for the first white coat.

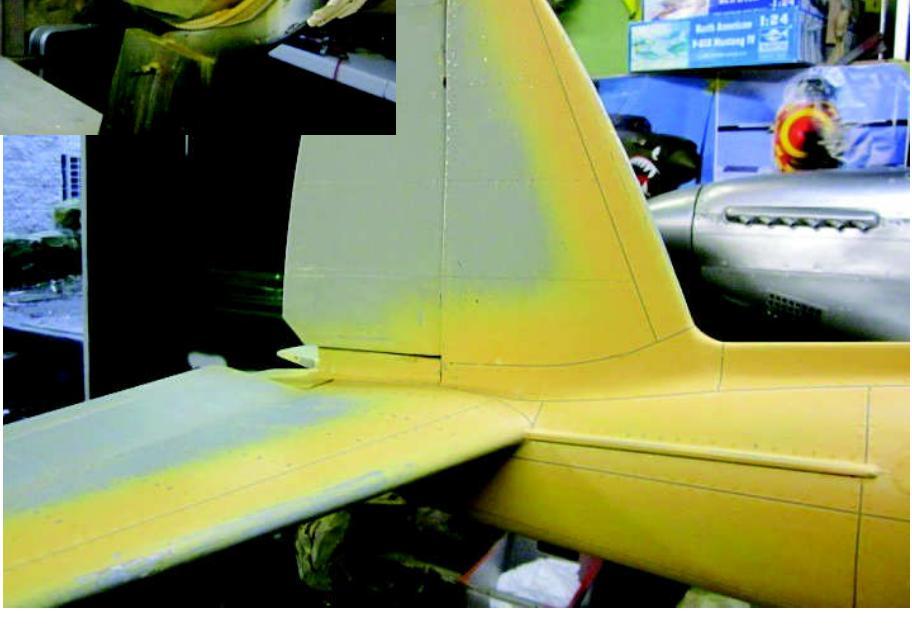
All the coloured paint will be Durobond air dry

acrylic semi gloss. I'll finish her off with a coat of Durobond 2 pot gloss clear to protect the surface from the nitro fuel. Weight is a real issue here so I'll be applying paint in the thinnest possible coats.

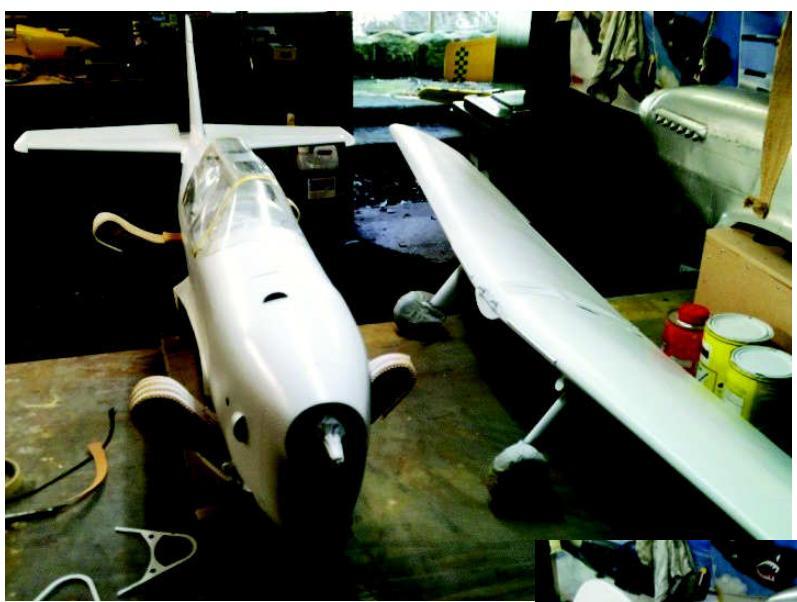
The white base coat is on and the canopy framing is work in progress.

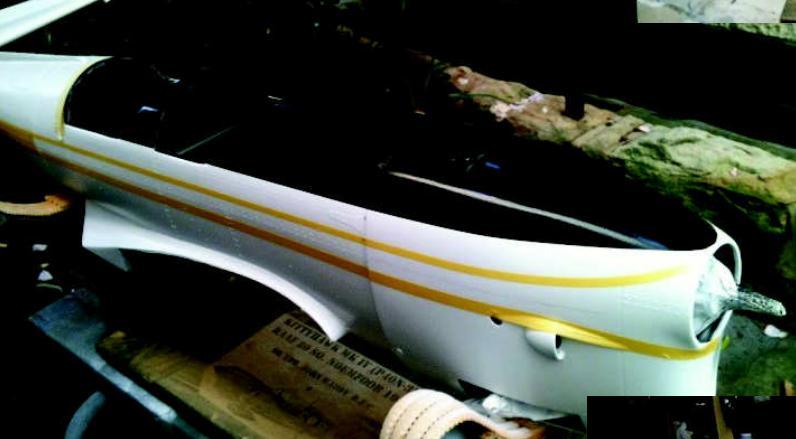
The black anti glare panel is done and next is the bright red flash down the fuselage sides, across the wing and fin.

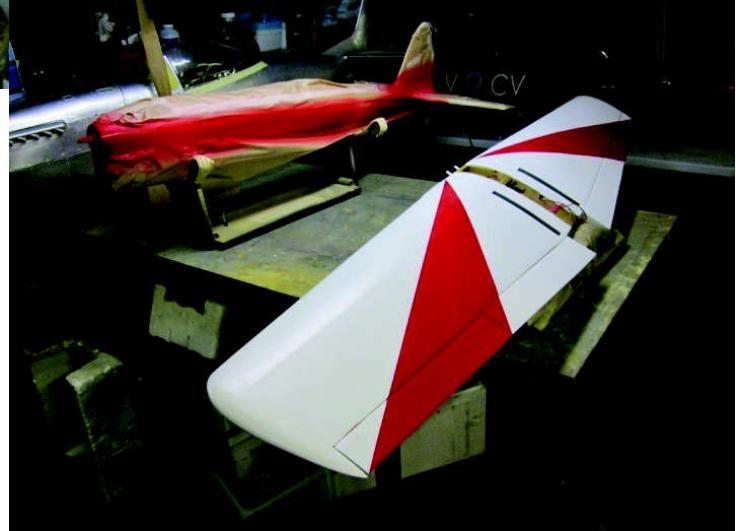
Wings finished and fuselage masked for stripes.

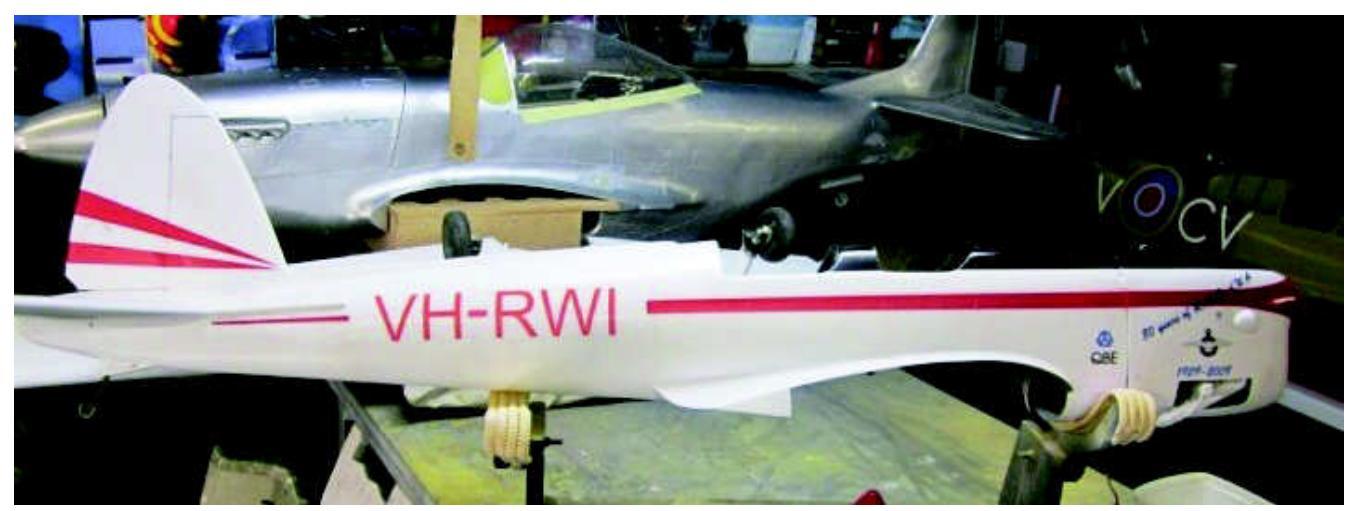
I made up a couple of pages of decals using MS Word and scanning a few images before editing in my favourite graphics software, Snagit. The decals are then printed on clear water slide paper with a laser printer and applied to the plane.

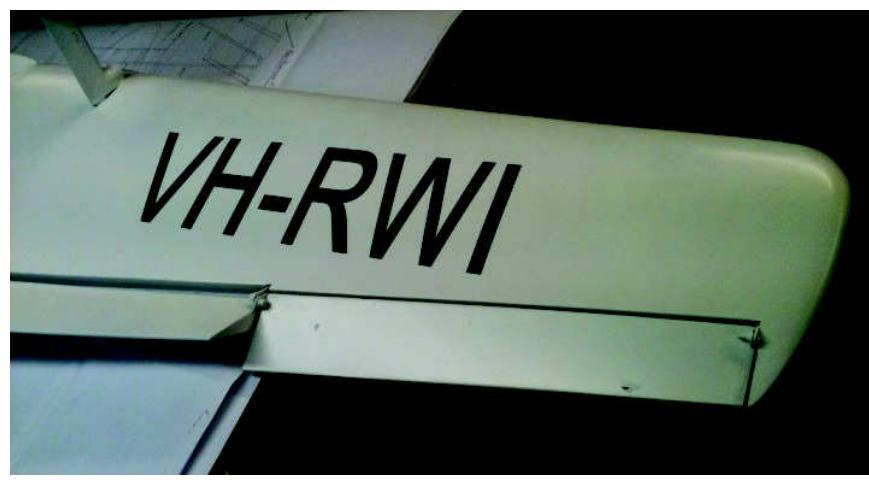
The underwing Australian rego decal was made with Col's beaut Roland vinyl cutter and is made from black adhesive vinyl sheet.

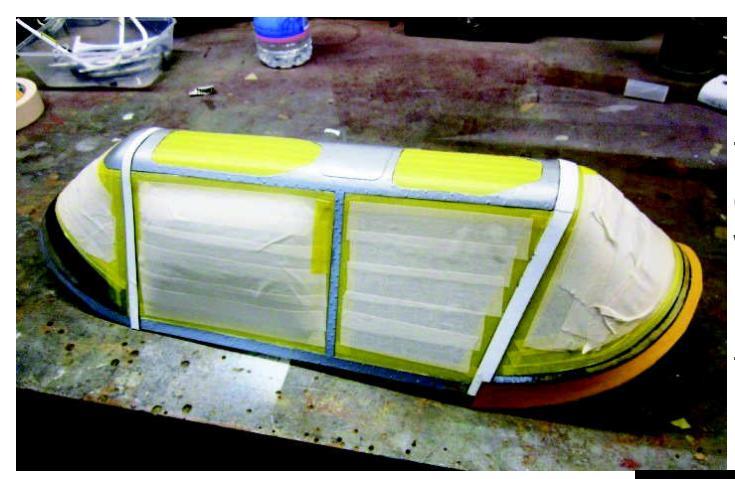
The external frames are made from cardboard glued to the clear plastic with canopy glue.

These frames will need priming then rivet detail added before spraying

with the same colour as the fuse-lage.

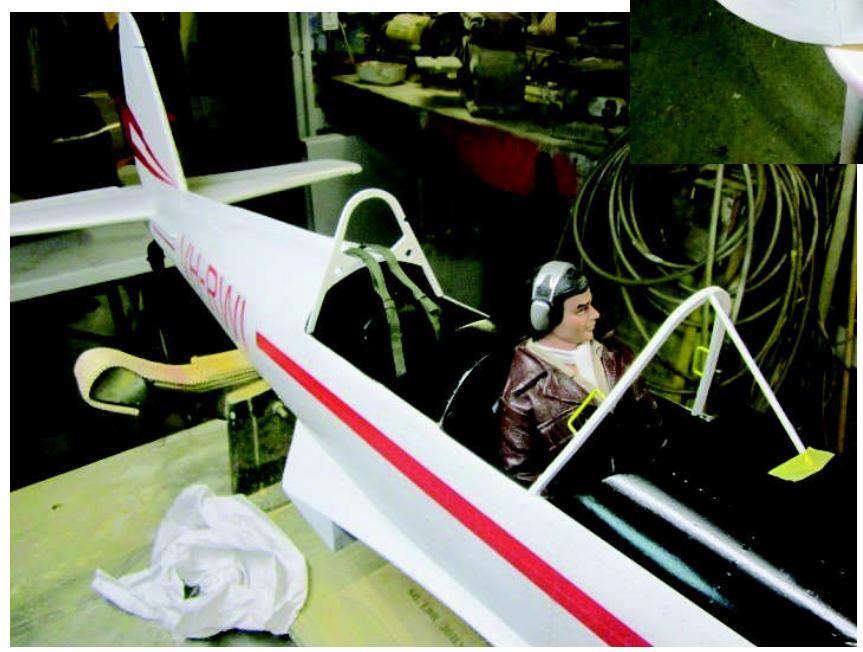
The internal frames are cut from 3mm ply and glued to the airframe to simulate the internal canopy structure.

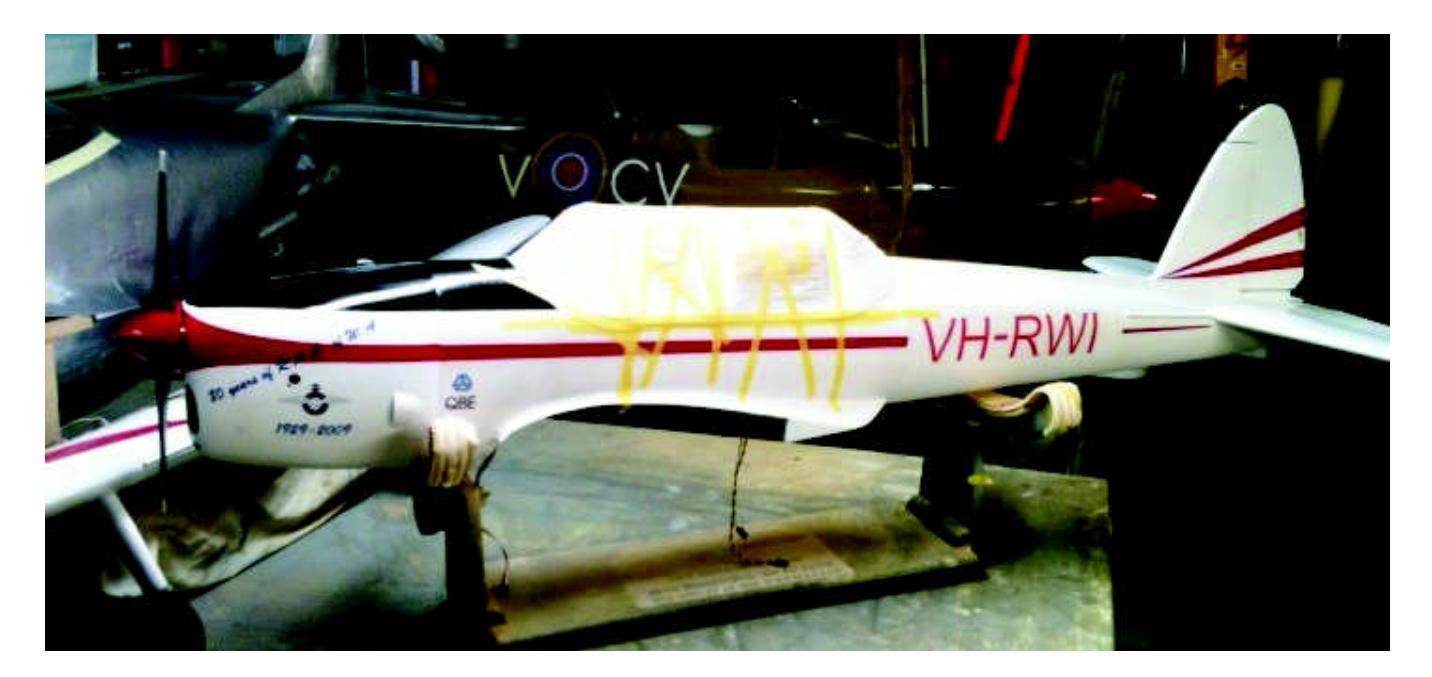
The canopy is glued in position with Pacer Canopy glue. It takes about a day to dry and then I can spray the complete plane with clear gloss.

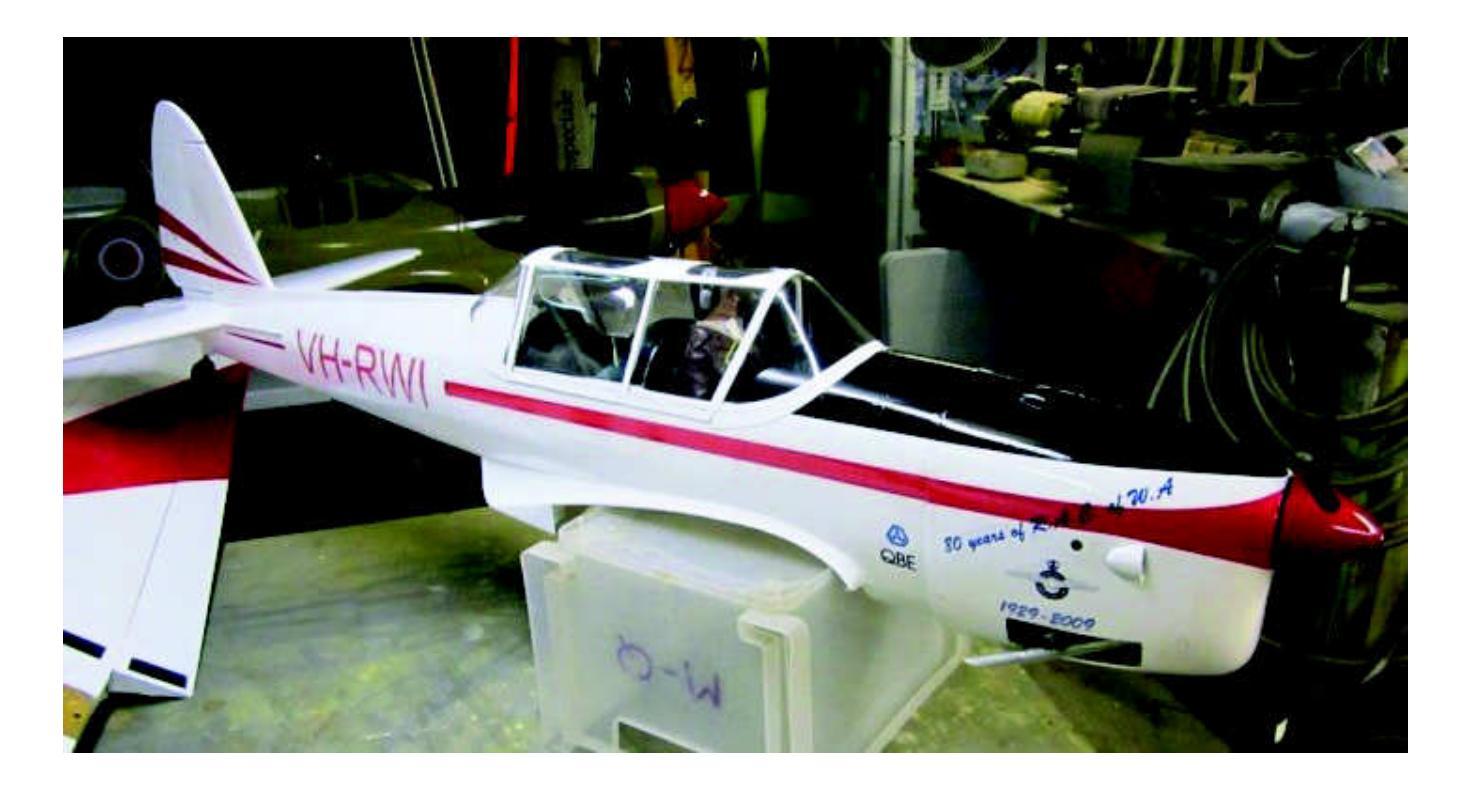
Two pot clear gloss Durathane now applied. Masking removed and now ready for re-balancing and then back to the air.
